# Design Guidelines - Cornices & Friezes

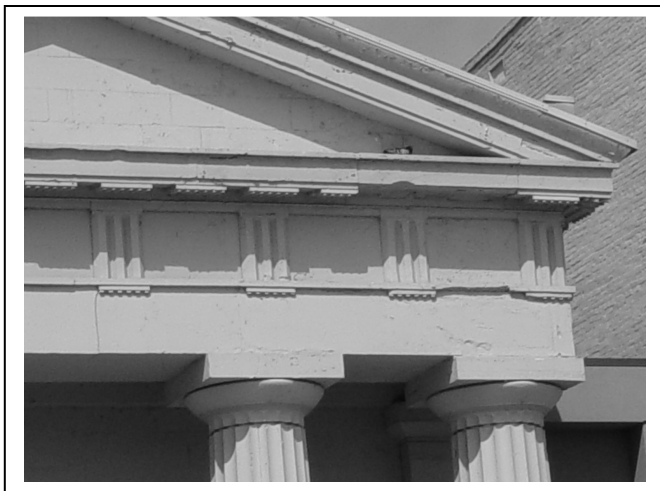
*Elements visible on the former Indiana State Bank include pediment (top), cornice (middle) and frieze (bottom)*

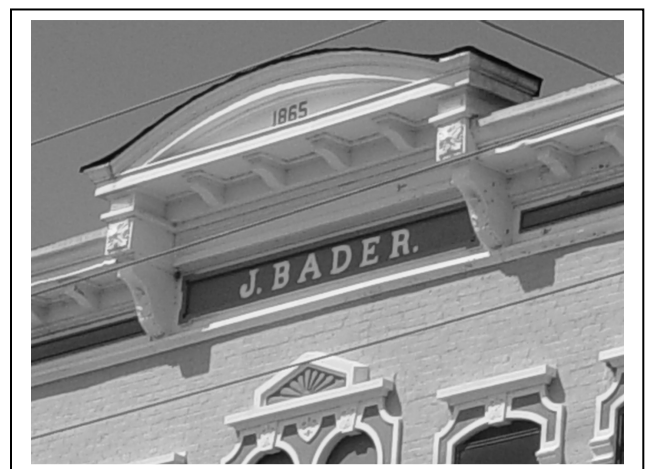
*The decorative cornice is a significant feature on the Bader Building (207 East Main Street).*
