Cornices, Friezes & Parapets

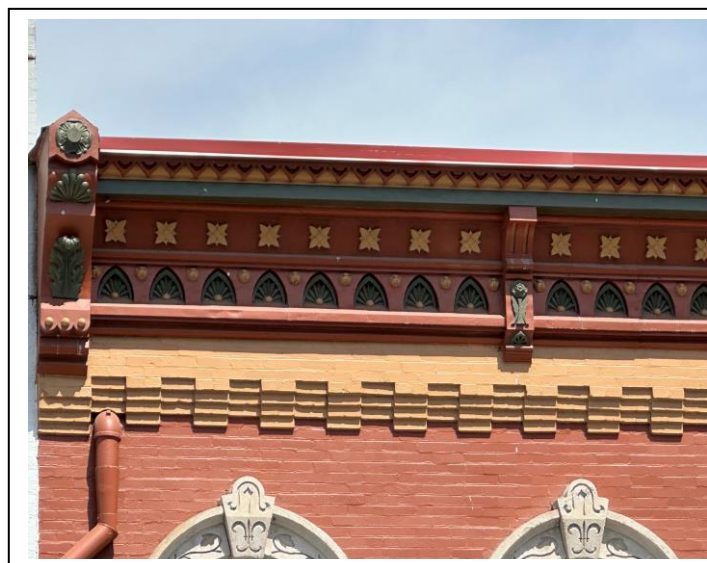
Both the metal cornice and the brick corbelling below contribute to the architectural interest of this East Market Street building. The multi-color paint scheme helps to show off the details.

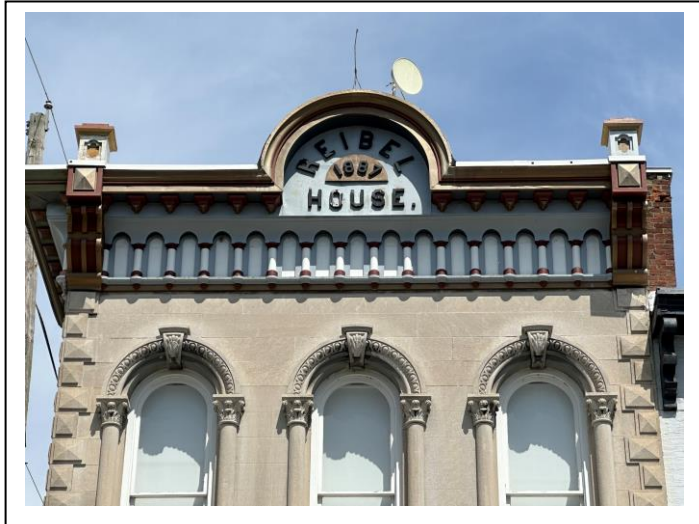
Elements visible on the former Indiana State Bank include pediment (top), cornice (middle) and frieze (bottom)

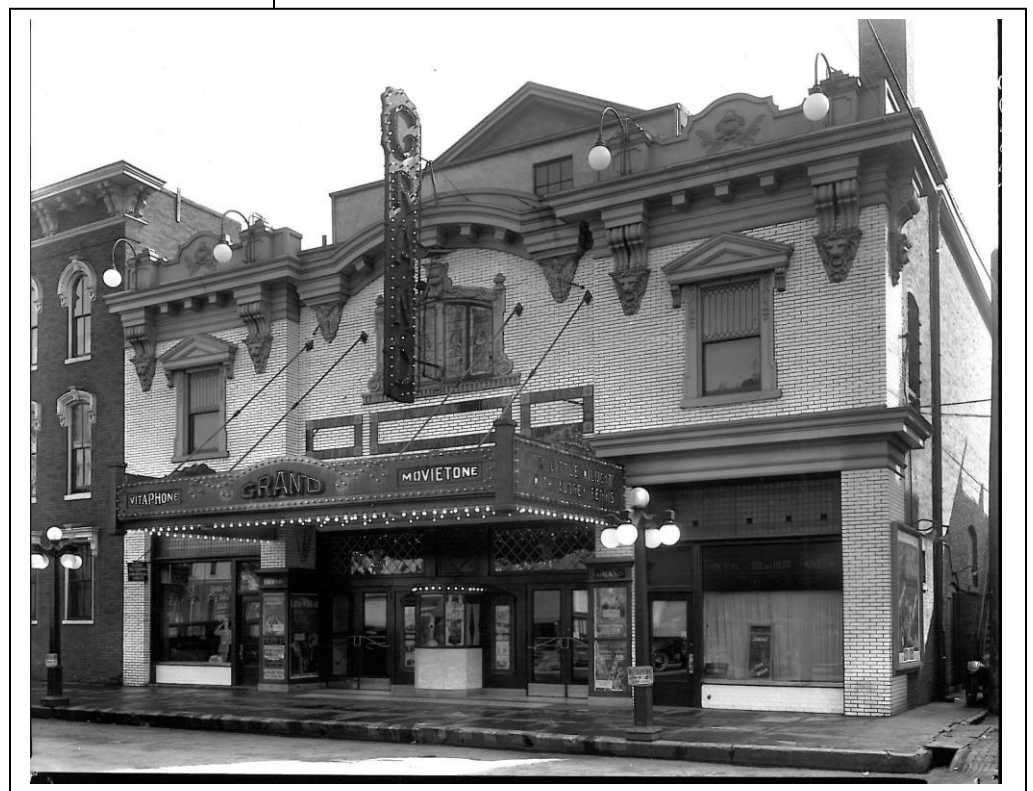
Built in 1909, the Grand Theater had a much different appearance – including a prominent cornice and decorative parapet – prior to its 1951 remodeling in the Art Moderne style.
