# Roofs

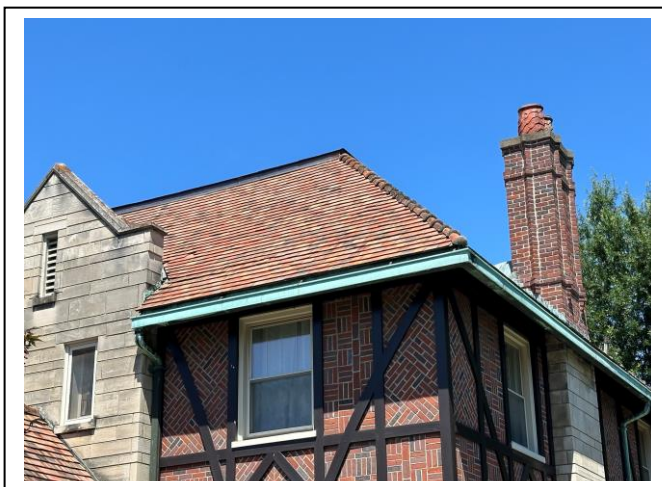
*All of the roof features – including the terra cotta tiles and the prominent end chimneys with ornate chimney pots – contribute to the architectural character of this DePauw Avenue home.*

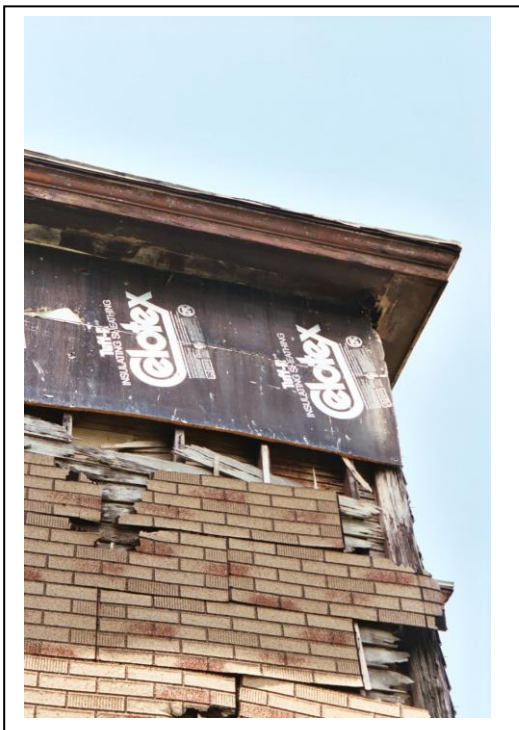
*Maintaining a sound roof and gutters is one of the most critical factors in preserving a structure. Here, failed box gutters have caused extensive damage to the siding and structure below.*

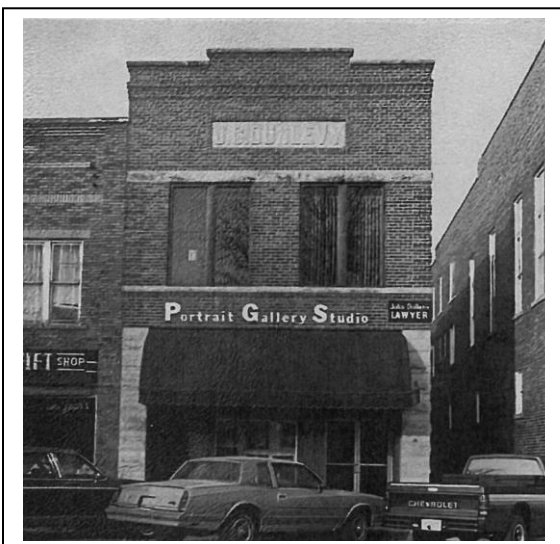
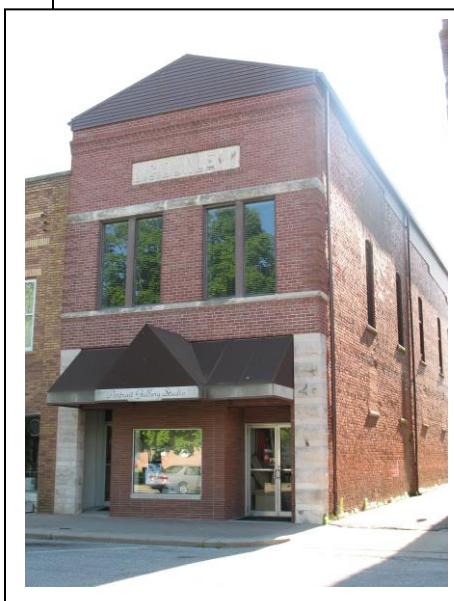
*As can be seen in this example from a nearby community, changes to roof shape and removal of roof features such as parapet walls can dramatically change a building's character.*

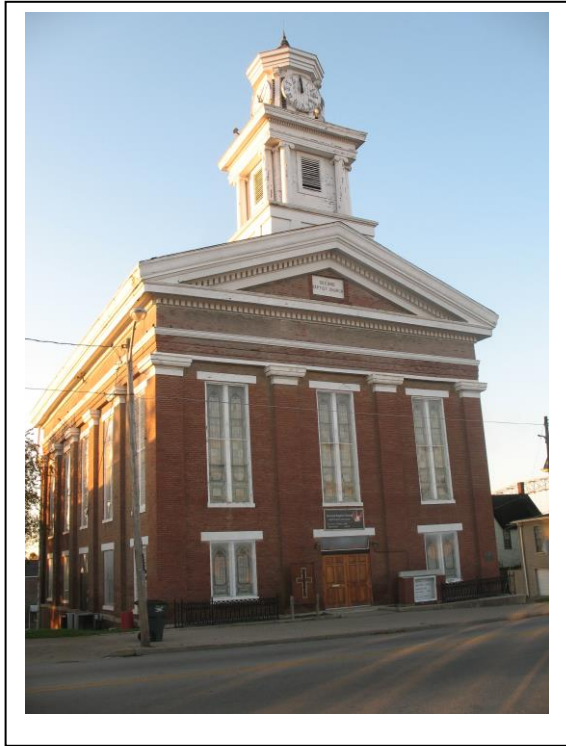
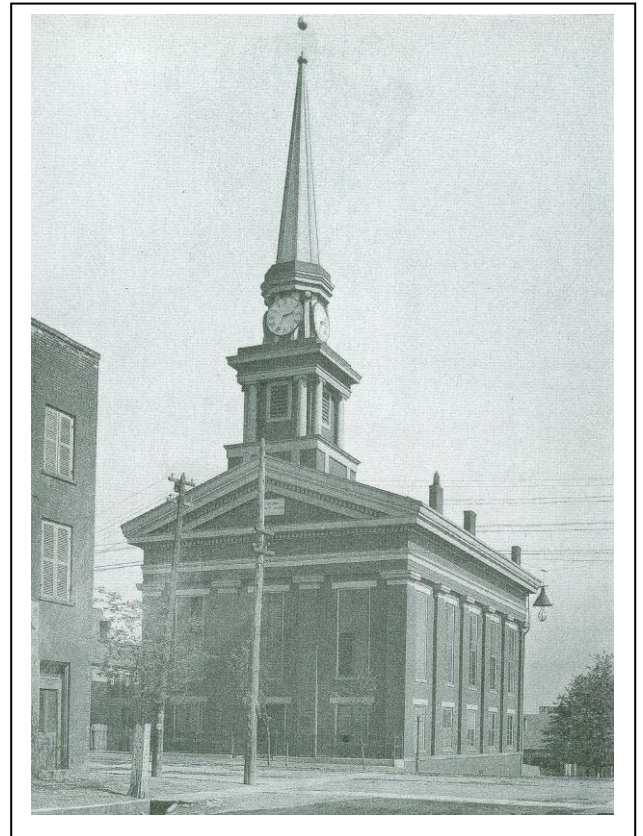
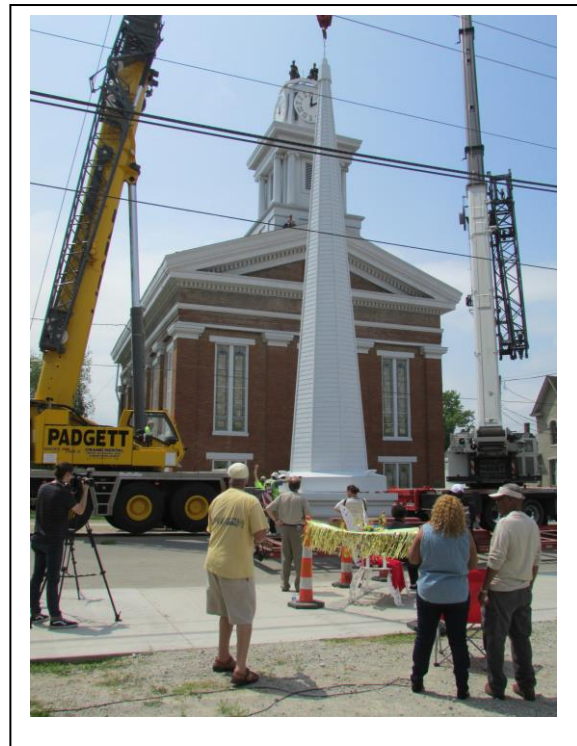
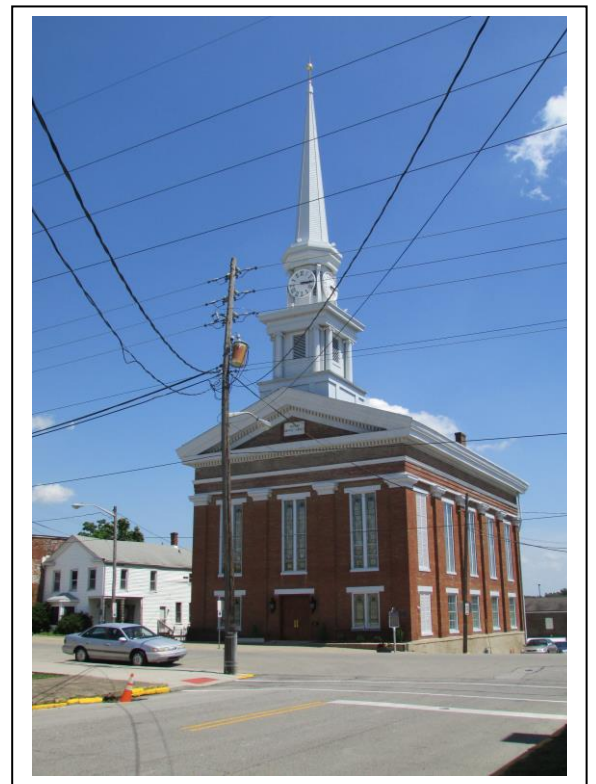
*The steeple on Second Baptist Church had been removed early in the 20<sup>th</sup> century after a lightning strike. Historic photos like the one above were used to faithfully replicate the steeple, and it was reinstalled in 2016.*
